# Veterans Administration Hospital (44)

13000 Sayre Street, Los Angeles County

**ROY G. JOHNSTON**

*Brandow & Johnston Associates  
Los Angeles, Calif.*

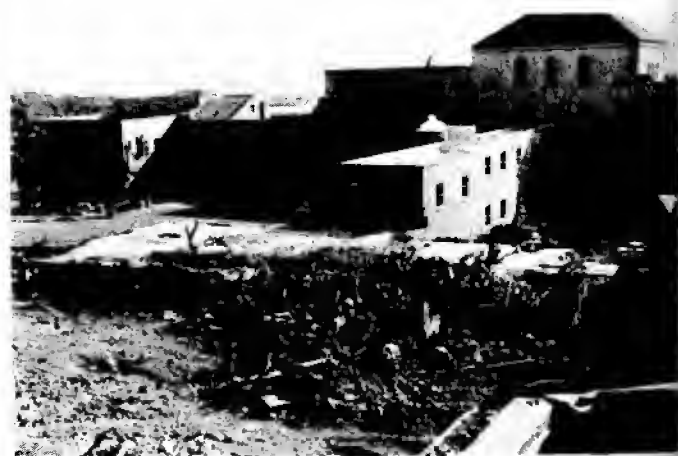
Unit identification number	Year constructed	Structural classification type	Inspection observations
1.....	1925...	I.....	Building had totally collapsed and debris has been removed (fig. 3).
2(a)....	1925...	I.....	Building had totally collapsed and debris has been removed (figs. 4, 5, and 6).
2(b)....	1950...	II.....	Frame was essentially intact. Exterior walls had diagonal hairline cracks. Chimneys from unit 2(a) had collapsed onto unit 2(b) and damaged east portion of roof. 1- to 3-inch downward displacement of adjacent grade was observed on north and west sides (figs. 4, 5, and 6).

Figure 3.—Veterans Administration Hospital. Unit 1, remaining debris. North elevation of unit 43 in background.

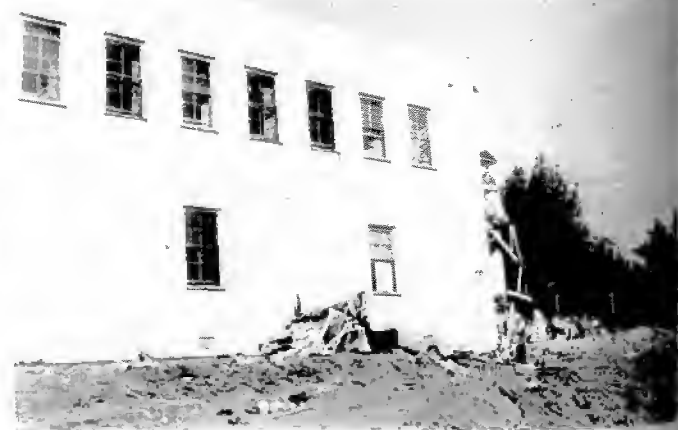
Figure 4.—Veterans Administration Hospital. Unit 2(b). South elevation with remains of unit 2(a) at far right.

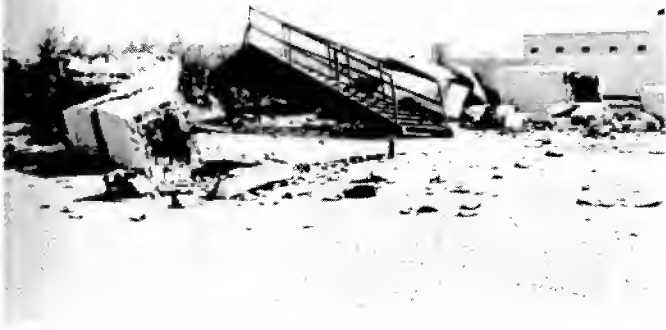
Figure 5.—Veterans Administration Hospital. Chimneys from unit 2(a) collapsed onto east end of unit 2(b) roof.

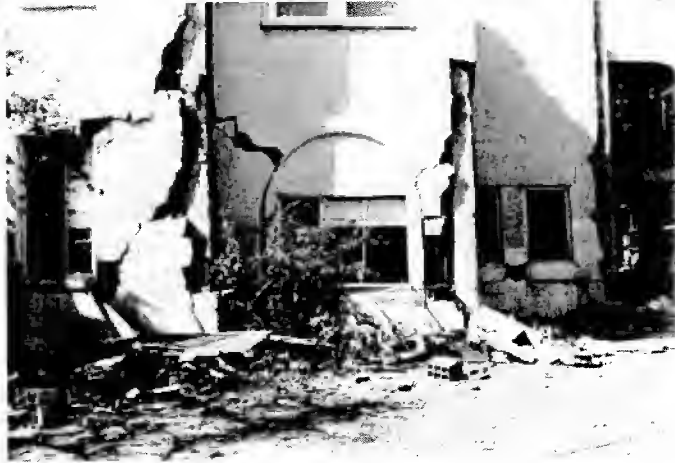
Figure 9.—Veterans Administration Hospital. Unit 5. East elevation.

4.....	1925...	I.....	Frame was standing, but portions of walls were collapsed and others had large fractures and cracks.
5.....	1925...	I.....	Frame was essentially intact. Walls had large fractures (fig. 9).

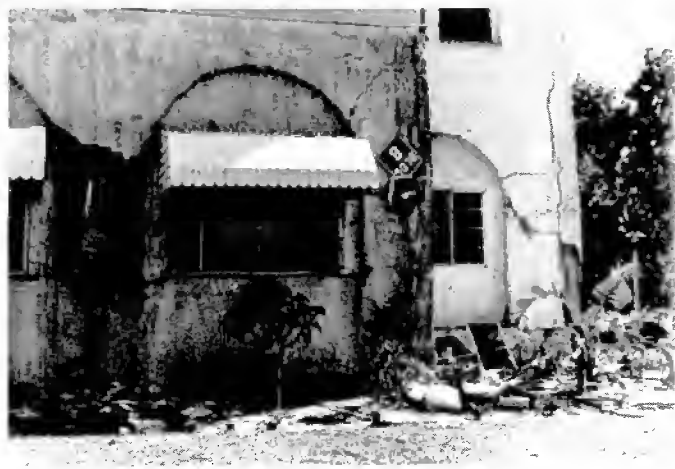
Figure 10.—Veterans Administration Hospital. Unit 6. West elevation.

6.....	1925...	I.....	Frame was standing, but several columns were fractured, spalled, and displaced horizontally. Portions of walls were collapsed and others had large fractures (fig. 10).

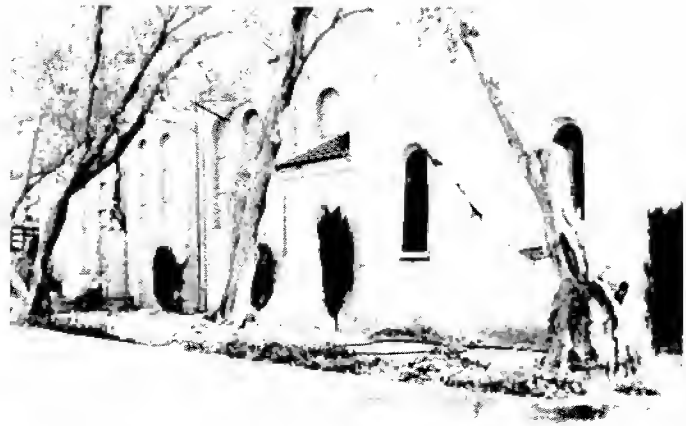
Figure 11.—Veterans Administration Hospital, Unit 7.  
North elevation of north wing.

7.....	1925...	I.....	Frame is essentially intact. Chimneys had collapsed onto roof. Ground floor had several 1/16-inch-wide cracks. Basement floor had several 1/8-inch-wide cracks and one 1 1/2-inch upward displacement. Exterior and basement walls had diagonal cracks. Interior walls had large fractures (fig. 11).

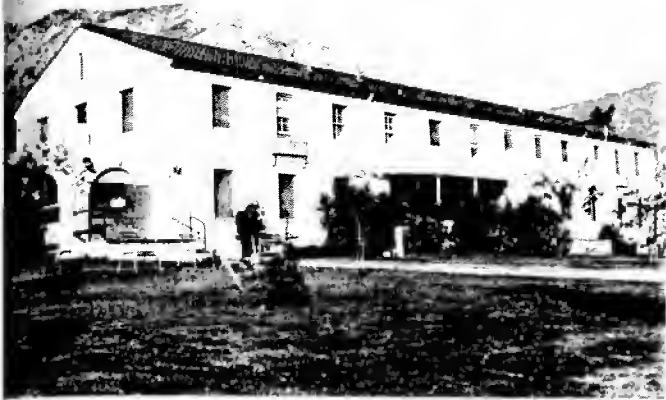
Figure 14.—Veterans Administration Hospital, Unit 11.  
South elevation.

10.....	1925...	I.....	Building was totally collapsed.
11(a)...	1925...	I.....	Frame was essentially intact. Chimneys were collapsed. Exterior walls had continuous horizontal cracks at floor- and rooflines. Portions of interior walls were collapsed and others had large fractures (fig. 14).
11(b)...	1929...	I.....	Frame was essentially intact. South exterior wall had continuous horizontal crack at roofline. North exterior wall had continuous horizontal crack at floorline. Interior walls had cracks from 1/8 inch to 1 inch in width (fig. 14).

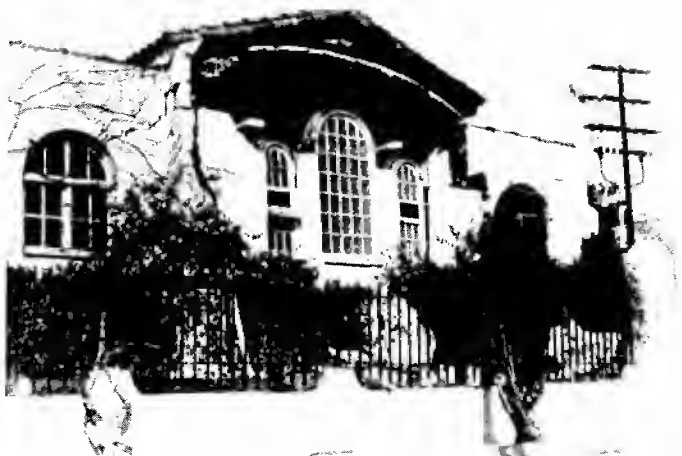
Figure 17.—Veterans Administration Hospital, Unit 19.  
South elevation.

19.....	1925...	III.....	Frame was standing, but portions of walls were collapsed and others had large fractures (fig. 17).
20.....	1925...	Metal tank.	Tank was essentially intact. Looking north, steel I-beam supports had rotated 90° counterclockwise. Tank was displaced about 4 inches in a west direction. Anchor bolts were deformed. Foundations were fractured and displaced 4 to 6 inches vertically (fig. 18).

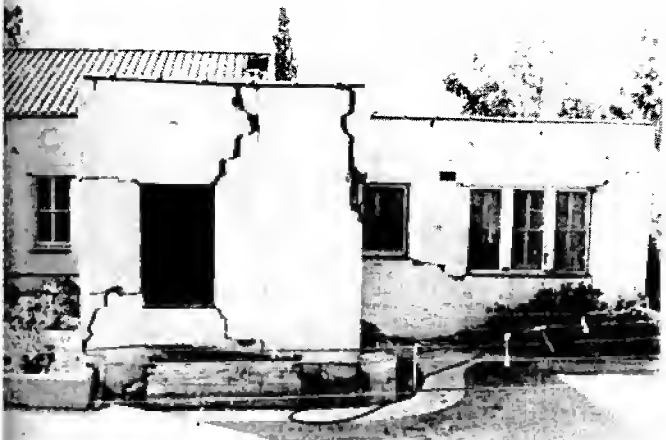
Figure 15.—Veterans Administration Hospital, Unit 13.  
North elevation.

Unit identification number	Year constructed	Structural classification type	Inspection observations
13.....	1925...	III.....	Frame was standing, but portions of exterior walls were collapsed and others had large fractures with horizontal displacements (fig. 15).

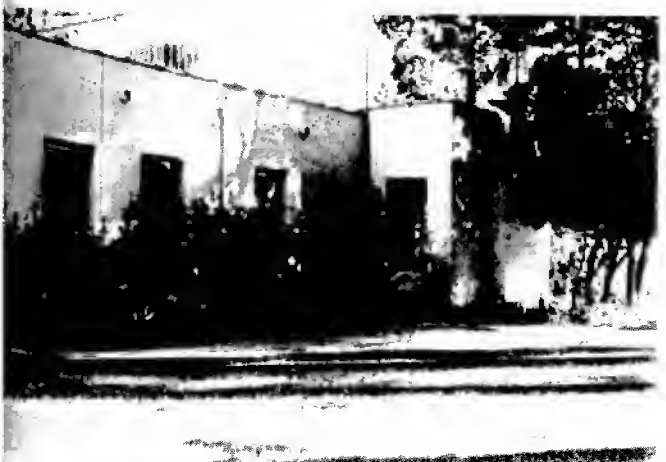
Figure 16.—Veterans Administration Hospital, Unit 18.  
North elevation.

18.....	1925...	III.....	Frame was essentially intact, but some exterior walls had cracks up to 1/8 inch in width. Chimney was fractured at roofline (fig. 16).

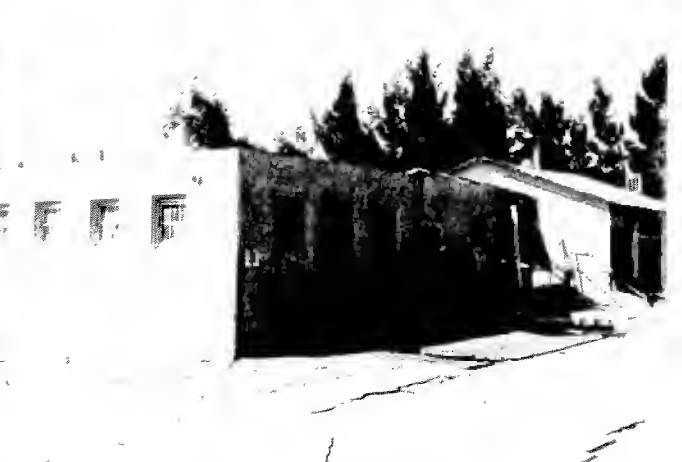
Figure 19.—Veterans Administration Hospital, Unit 23.  
East elevation.

23.....	1931...	IV.....	Frame was essentially intact. Exterior walls had continuous horizontal cracks at floorline. 2-inch downward displacement of adjacent grade was observed on north side (fig. 19).

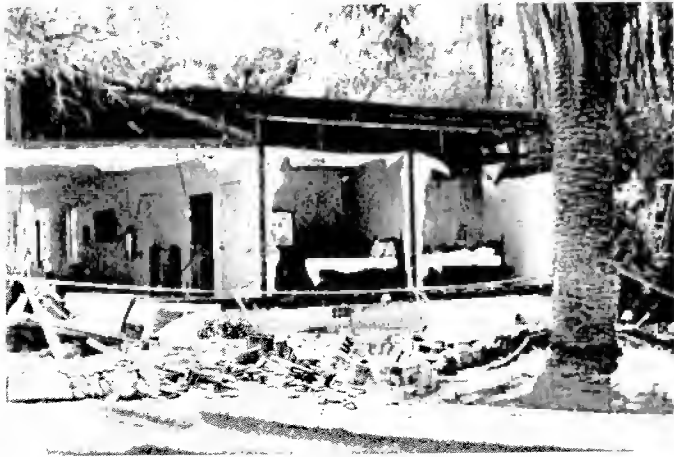
Figure 20.—Veterans Administration Hospital. Unit 28.  
West elevation.

28.....	1928...	III.....	Frame was standing, but majority of exterior walls were collapsed (fig. 20).
29.....	1930...	II.....	Frame was essentially intact with no apparent damage. Wood frame canopy between units 26 and 29 was collapsed (fig. 21).

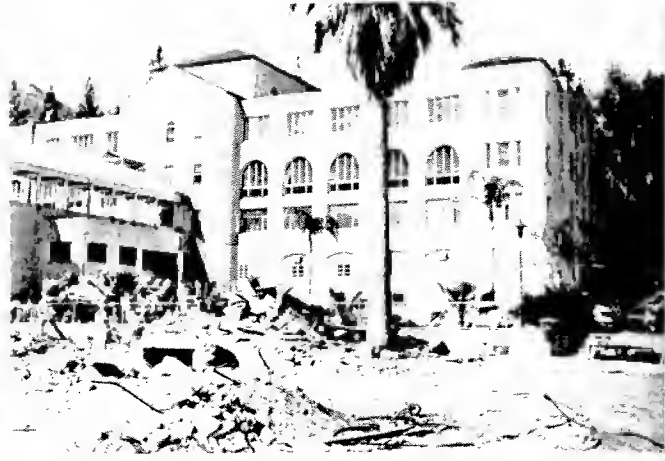
41.....	1938...	II.....	Frame was essentially intact. Some walls had diagonal hairline cracks. Basement slab-on-grade had 1/16-inch-wide continuous crack running parallel to and 6 feet south of north exterior wall. 1- to 3-inch downward displacement of adjacent grade was observed on north and west sides (fig. 23).

Figure 23.—Veterans Administration Hospital. Unit 41. South  
elevation with remaining debris of unit 2(a) in foreground.

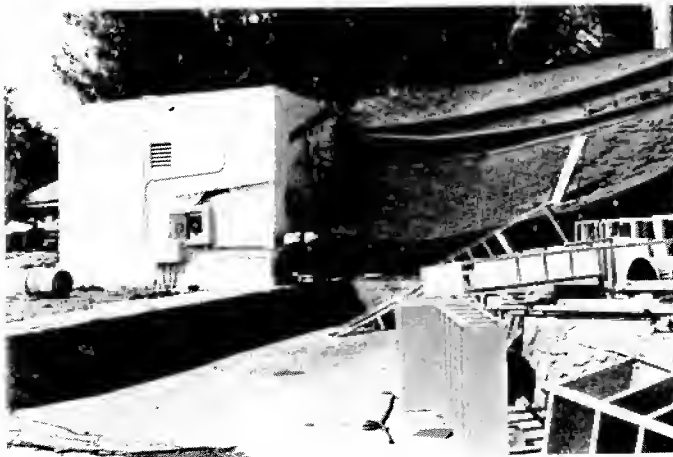
Figure 21.—Veterans Administration Hospital. Unit 29. East  
elevation, showing collapsed canopy between units 29 and 26.

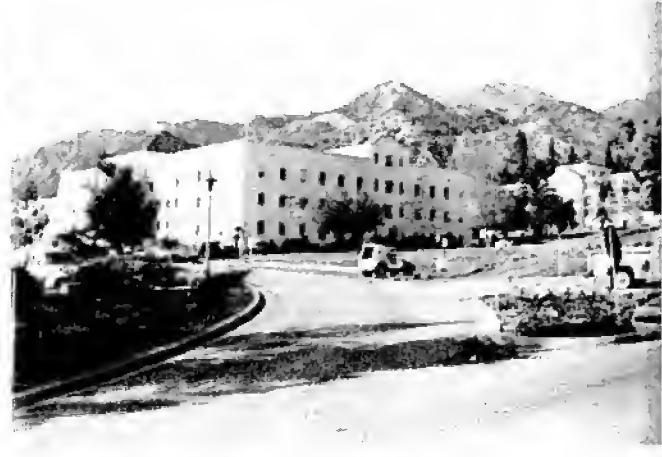
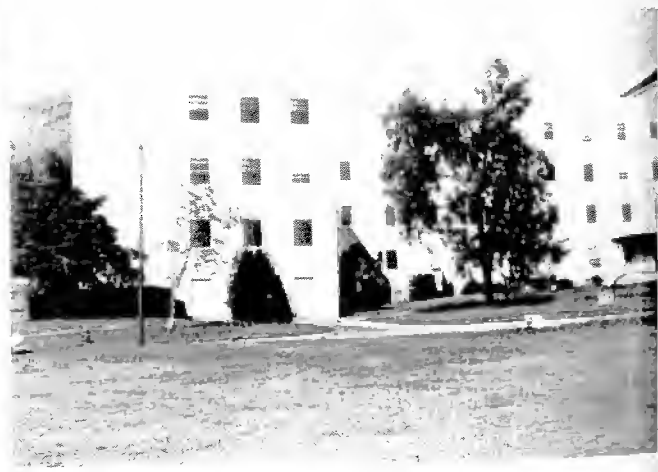
42.....	1940...	III.....	Frame was essentially intact. Walls had diagonal cracks up to 1/8 inch in width.
43.....	1949...	II.....	Frame was essentially intact. Some walls had diagonal hairline cracks (figs. 24 and 25).

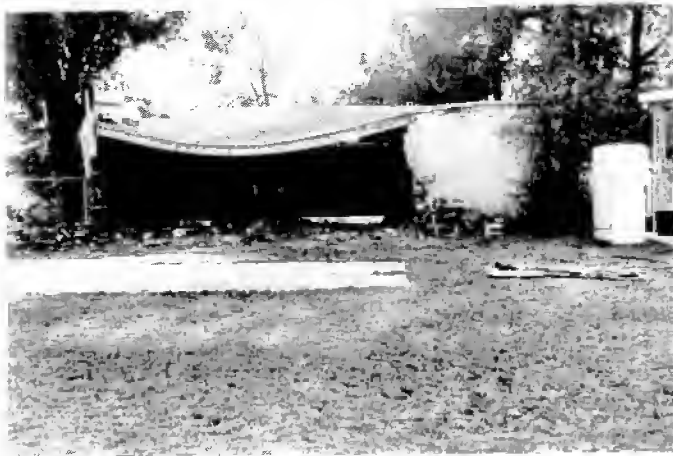
Figure 22.—Veterans Administration Hospital. Unit 33.  
North elevation.

33.....	1939...	III.....	Frame was standing, but large portion of roof was collapsed and most of north wall was collapsed (fig. 22).
34.....	1932...	V.....	Frame was essentially intact with no apparent damage.

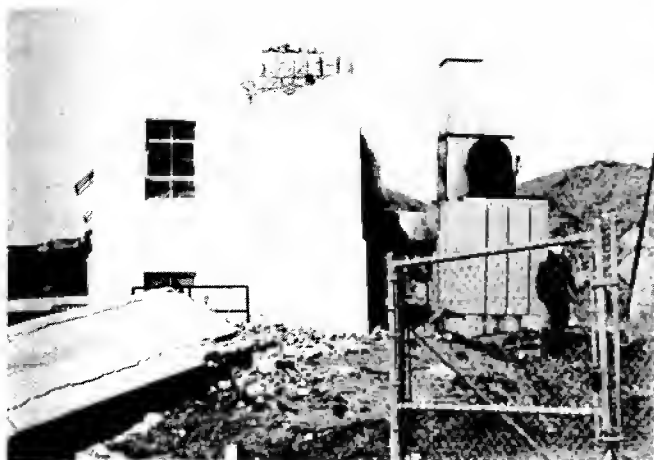
Figure 26.—Veterans Administration Hospital, Unit 44.  
East elevation.

44.....	1949...	II.....	Frame was essentially intact. Some walls had diagonal hairline cracks. Chimney was collapsed (fig. 26).
45.....	1949...	II.....	Frame was essentially intact. South wall had a diagonal crack. North brick filler wall had several cracks and was bowed outward. Brick boiler walls had several large fractures with horizontal displacements (figs. 27 and 28).

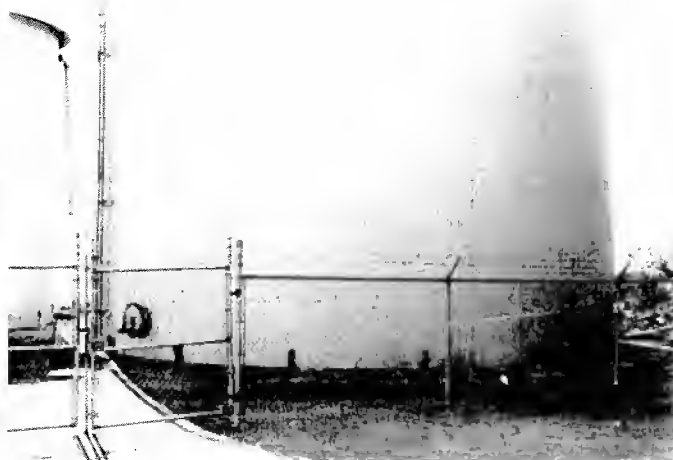
Figure 29.—Veterans Administration Hospital, Unit 47.  
North elevation.

47.....	1949...	Metal tank.	Tank was essentially intact. Slab-on-grade at anchor bolts had short hairline cracks. Water seepage was observed at the base (fig. 29).

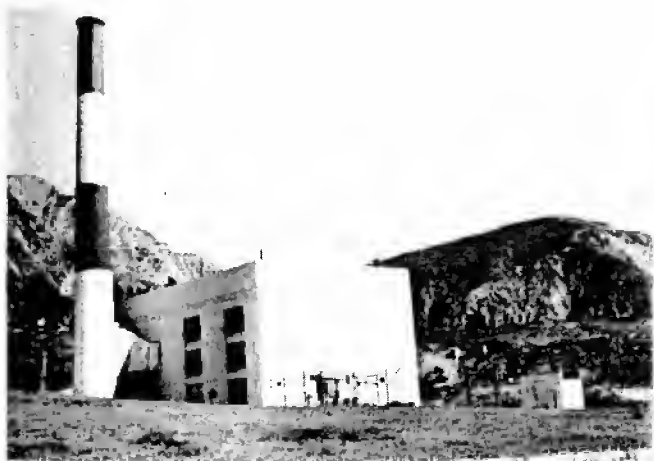
Figure 27.—Veterans Administration Hospital, Units 45 and 49.  
South elevation.

49.....	1949...	Chimney with reinforced concrete wall.	Chimney was essentially intact. Wall had continuous horizontal hairline cracks at approximately 20 feet center to center, probably at construction joints. 2-inch downward displacement of adjacent grade was observed on north side (fig. 27).

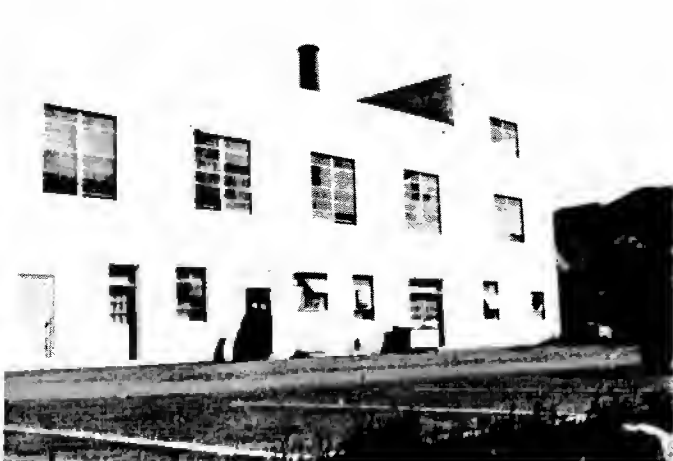
Figure 30.—Veterans Administration Hospital, Unit 50.  
South elevation.

50.....	1951...	II.....	Frame was essentially intact. South exterior wall had horizontal hairline cracks at top and bottom of piers between window openings. Interior basement walls had diagonal hairline cracks. 1- to 6-inch downward displacement of adjacent grade was observed on north and east sides (fig. 30).

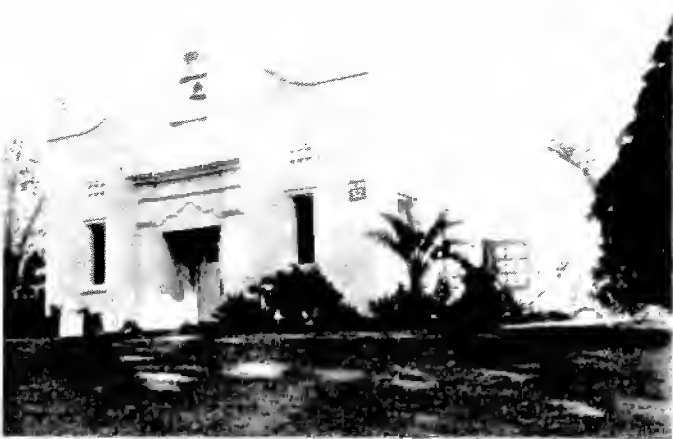
Figure 31.—Veterans Administration Hospital, Unit 52.  
West elevation.

52.....	1951...	II.....	Frame was essentially intact. No apparent damage was observed (fig. 31).
53.....	1950...	II.....	Frame was essentially intact. No apparent damage was observed. Exterior mechanical equipment (water filters) was displaced and pipes were broken (fig. 32).

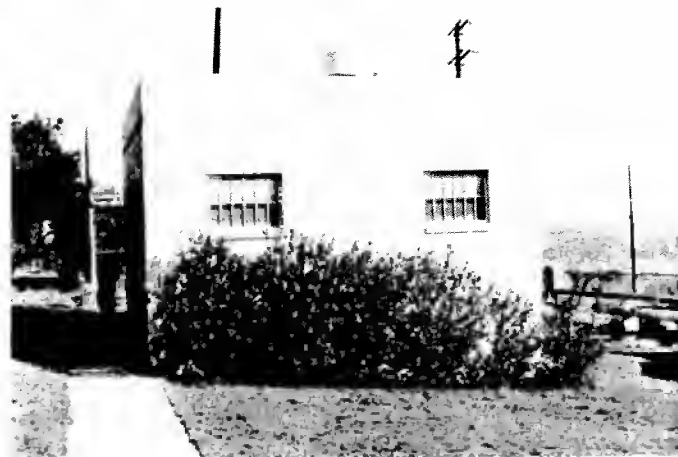
*Figure 33.—Veterans Administration Hospital. Unit 54.  
West elevation.*

54.....	1950...	II.....	Frame was essentially intact. No apparent damage was observed (fig. 33).

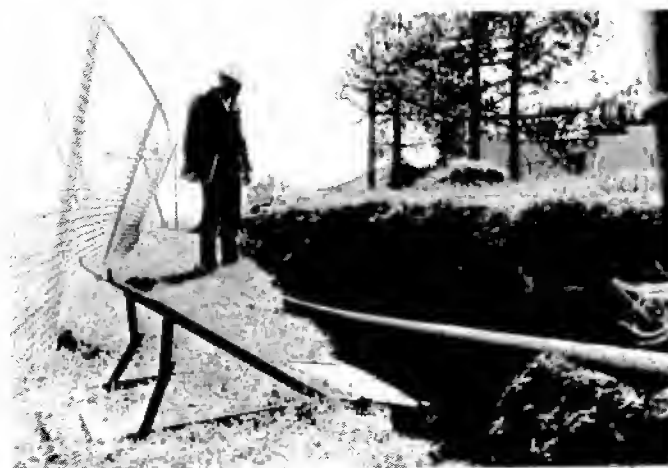
*Figure 35.—Veterans Administration Hospital. Earth slippage  
along hilltop north of units 8 and 10.*

Although some hillside earth slippage was observed (fig. 35), the building failures were precipitated by intense areal ground motion rather than localized earth faulting or permanent ground movements. An examination of the data in table 2 reveals that, for the most part, the 26 buildings and additions constructed prior to 1933 sustained the greatest structural damage. Four of these buildings totally collapsed during the initial moments of the main shock, and the remainder, with the exception of unit 29 (paint and oil storage building, fig. 21) and unit 34 (greenhouse), are in various stages of deterioration. Of the two ancillary structures built prior to 1933, unit 20 (water tank, fig. 18) incurred substantial damage to the support beams and foundations, but unit 40 (automatic valve chamber) experienced no observable structural damage.
